RESTORING THE RECREATIONAL POTENTIAL OF SMALL IMPOUNDMENTS

The Marion Millpond Experience

*An Inland Lake Renewal
and Management Demonstration
Project Report*

Technical Bulletin No. 71
DEPARTMENT OF NATURAL RESOURCES
Madison, Wisconsin

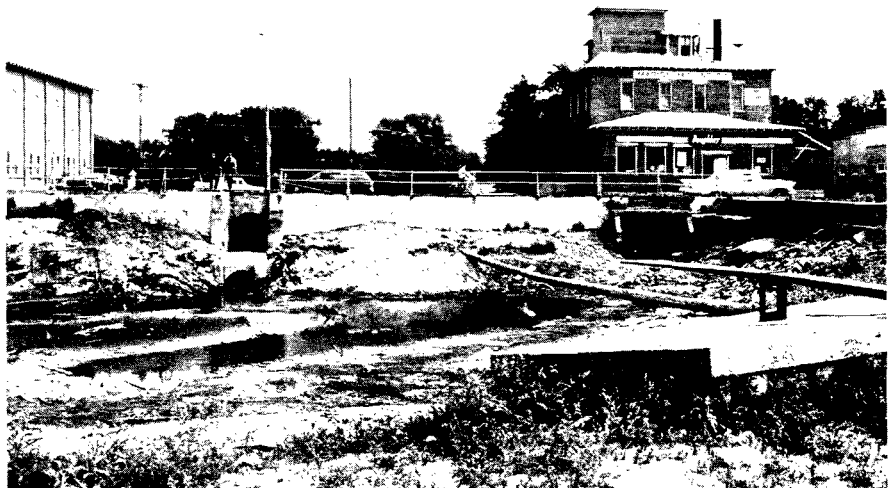
FIGURE 4
The Marion dam showing the emergency wasteway and flume (looking east).

leave behind a permanent facility to drain the pond in the future (Fig. 4).^{*} This work was performed by the citizens of Marion (for less than \$5,000) during May and June 1969, and by late July 1969, the Marion Millpond was drained (Fig. 5).

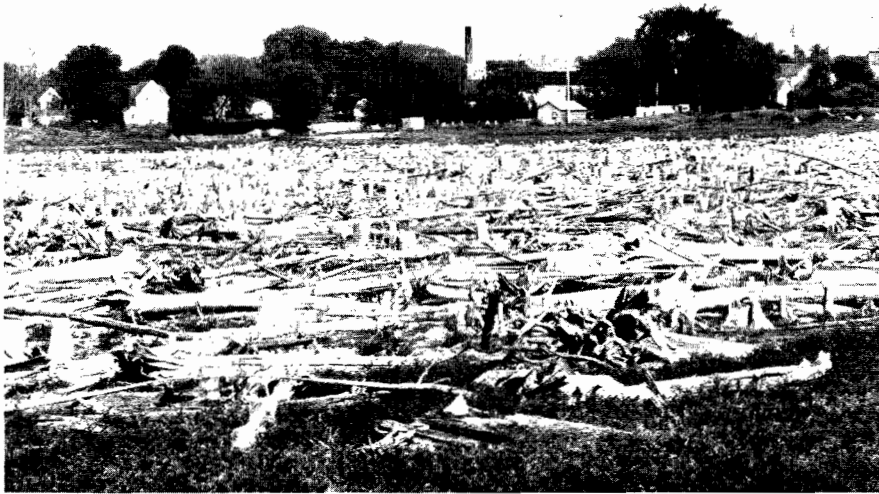
FIGURE 6

Stump field on millpond bottom.

Stump and Log Removal. With the pond filled, thousands of submerged and partially submerged stumps and toppled trees (left behind when the pond was originally flooded) hindered recreation and boating. With the pond drained, they were present almost everywhere and hampered work on the pond bottom (Fig. 6). Prior to draw-down, stump removal activities had been entirely directed at cutting off exposed stumps at the water line. After drawdown, cutting of stumps as close to the ground as possible was continued, but failed to permit adequate preparation of the pond bottom for subsequent treatments. Therefore, intensive work "bees" were organized by the community to mechanically and manually remove debris, logs and stumps embedded in the pond sediments. Although the work was facilitated by construction and farm machinery in part donated by local people and businesses, the work was tedious, back-breaking and slow.

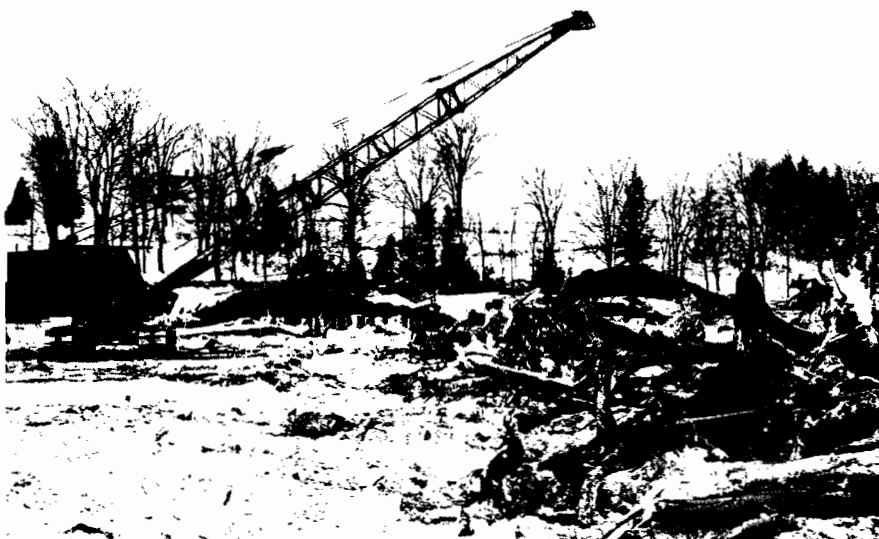
FIGURE 7

Winter stump removal.

During the 1969-1970 winter, roads were frozen-in on the pond bottom. This enabled contracted heavy equipment to work on the pond bottom proper. Deeply embedded logs and stumps were removed by a drag line, wind-rowed by a front-end loader, and moved off the pond bottom by truck. (Fig. 7). The large volumes of stumps and debris were trucked to a disposal area. (In spite of a great deal of thought, no salvage value was found for this wood – largely cedar and

elm). This approach was more effective than working directly on the unfrozen pond bottom. The heavy equipment expedited the job, and about forty acres were cleared in this way. However, this work proved very expensive.

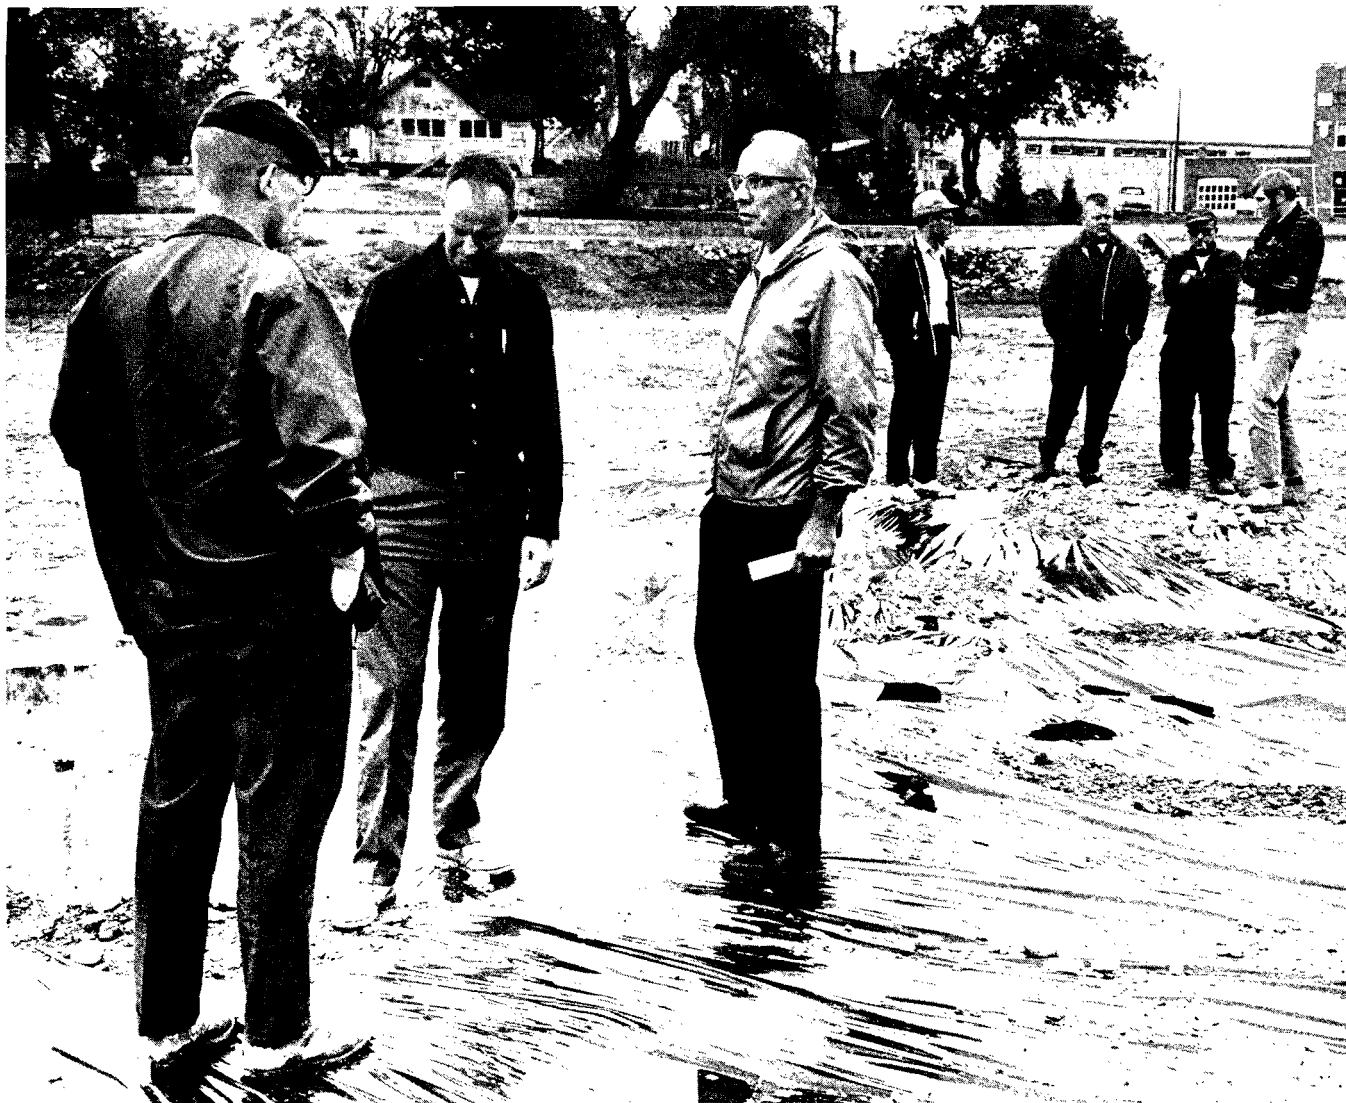
FIGURE 8

Plastic sheeting anchored in place prior to covering.

The plastic sheeting was applied in the winter, when frozen ground and ice cover allowed machinery to be used for transporting and spreading sheeting and anchoring materials. Sheeting was laid down by a team of workers, and anchored temporarily with rocks (Fig. 8). The sheeting was perforated to permit gases from the underlying sediments to escape. From 3-6 inches of sand, gravel or "pit-run" sand and gravel was then spread over the sheeting by means of a front-end

Although some sheeting was placed directly on frozen ground, residual debris and uneven topography impeded application. It proved far more efficient to apply the sheeting on ice, in the following manner: Water levels were controlled to govern the extent of ice cover on the pond; the objective was to have ice cover formed over all areas to be treated, with a minimal depth of water under the ice. Snow was cleared from the portion of the ice to be covered, and the sheeting and covering material were placed on the ice (Fig. 10). Then water levels were lowered to collapse the treatment "package" onto the pond bottom.

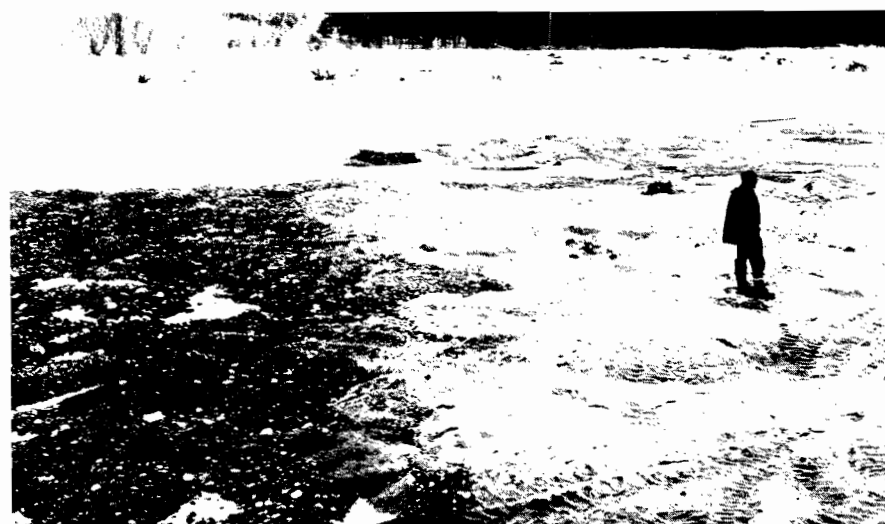
FIGURE 11
Gravel and sand covering over cleared areas.

Other areas of the pond were covered only with sand or gravel for comparative purposes (Fig. 11). The location, description and evaluation of the treated areas are reported in Appendix C and Figure 12.

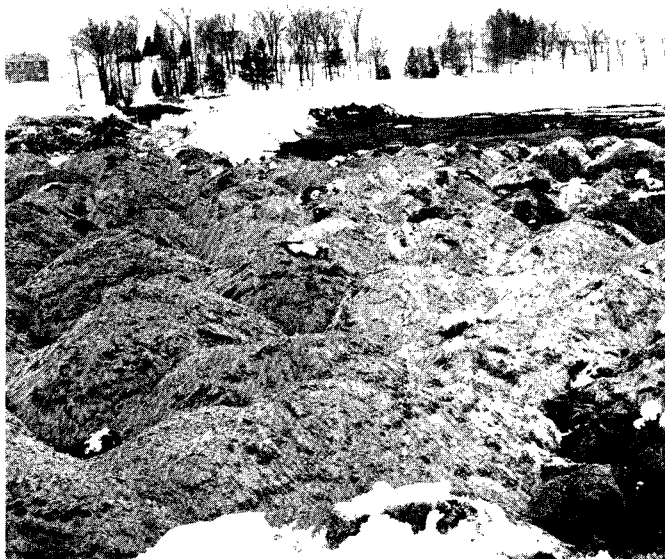
FIGURE 13
Construction of the Lion's Point Beach.

tom, and covered with sand, which was then spread to a 1:8 grade (Figs. 13 and 14). A boat dock was built north of the new beach and picnic tables and other facilities were installed.*

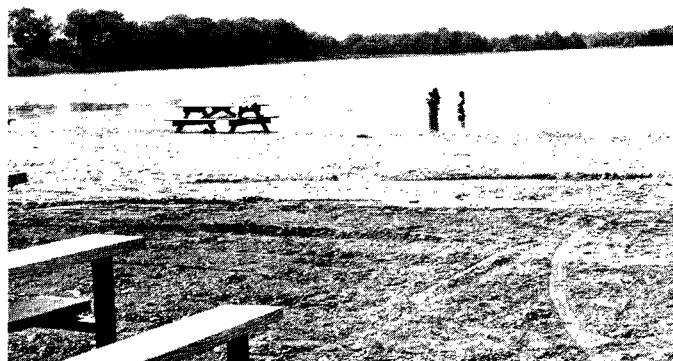
FIGURE 14
Lion's Point Beach – after construction.

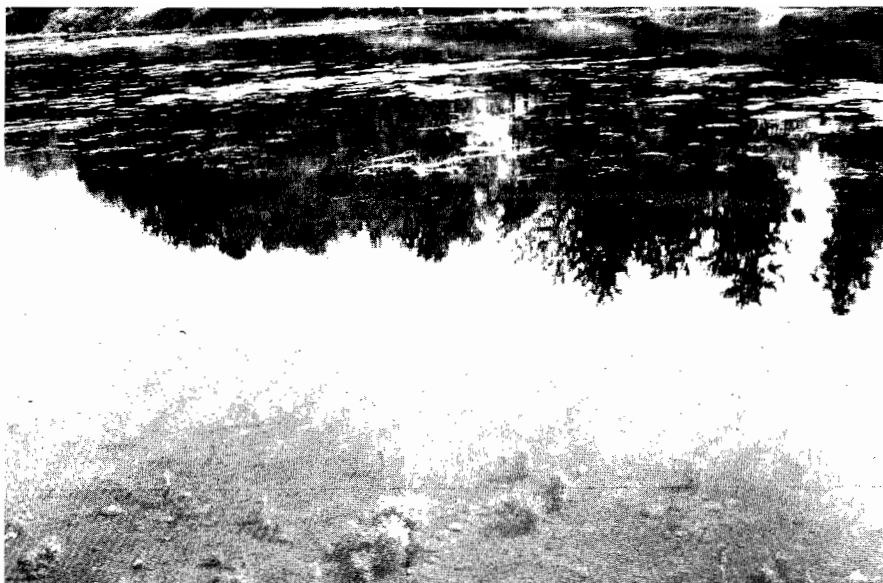
FIGURE 15
Plant growth in treated areas (foreground) vs. untreated areas during the second year after treatment.

Based upon this two-year comparison, treated areas generally exhibited less plant growth than untreated areas (Fig. 15). Data for 1972 indicate that the areas that were blanketed with sheeting and sand or gravel had substantially less growth than those areas which were only dredged or dredged and sandblanketed; an exception to this occurred where dredging was done to a depth exceeding the photic zone (Treatment 9, see Appendix C). Treated areas have a different vegetation than the control areas. Macrophytic algae of the genus *Chara* form the majority of the plant growth in the treated areas. In contrast, rooted angiosperm macrophytes constitute most of the plant growth in control areas. The shallow-water treated areas had a high biomass of filamentous algae in 1971. Production of this algae dropped off markedly from 1971 to 1972, although small amounts were present clinging to plant tops and shoreline areas. The decrease in filamentous algae was expected, in view of competition from the higher biomasses of other plants in 1972.
